REPORT OF FATAL COAL OUTBURST (BUMP) ACCIDENT

NO. 17 MINE
ISLAND CREEK COAL COMPANY
RED JACKET, MINGO COUNTY, WEST VIRGINIA

November 6, 1969

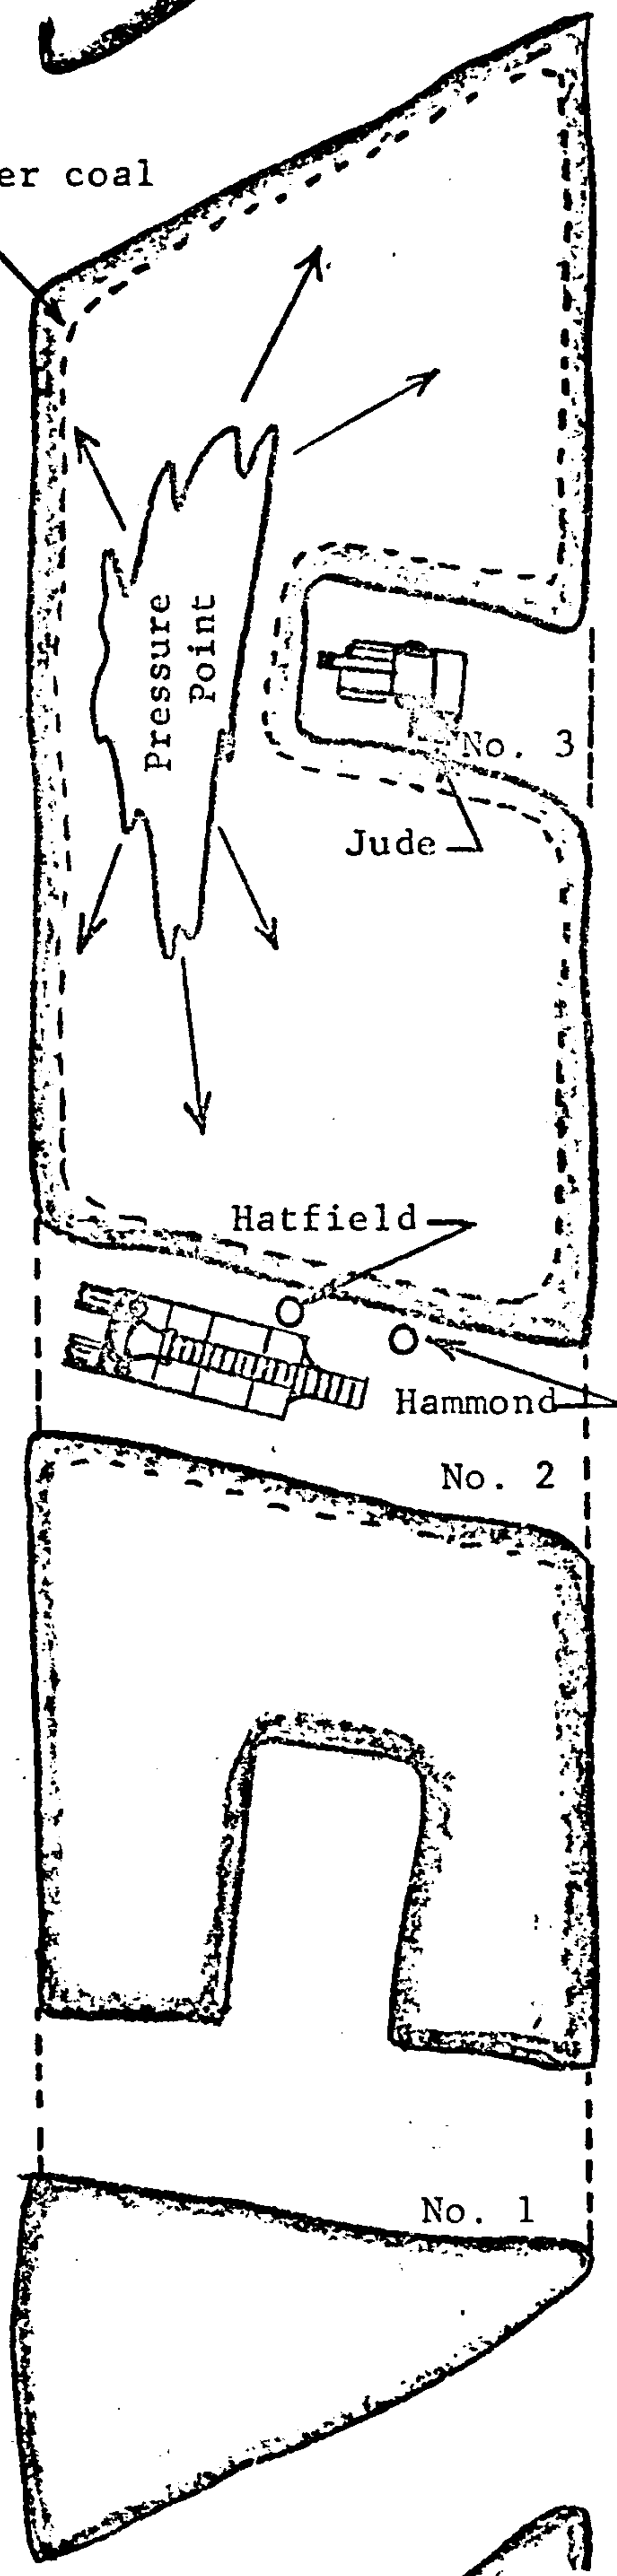
SKETCH NO. 2

Rib line after coal
outburst

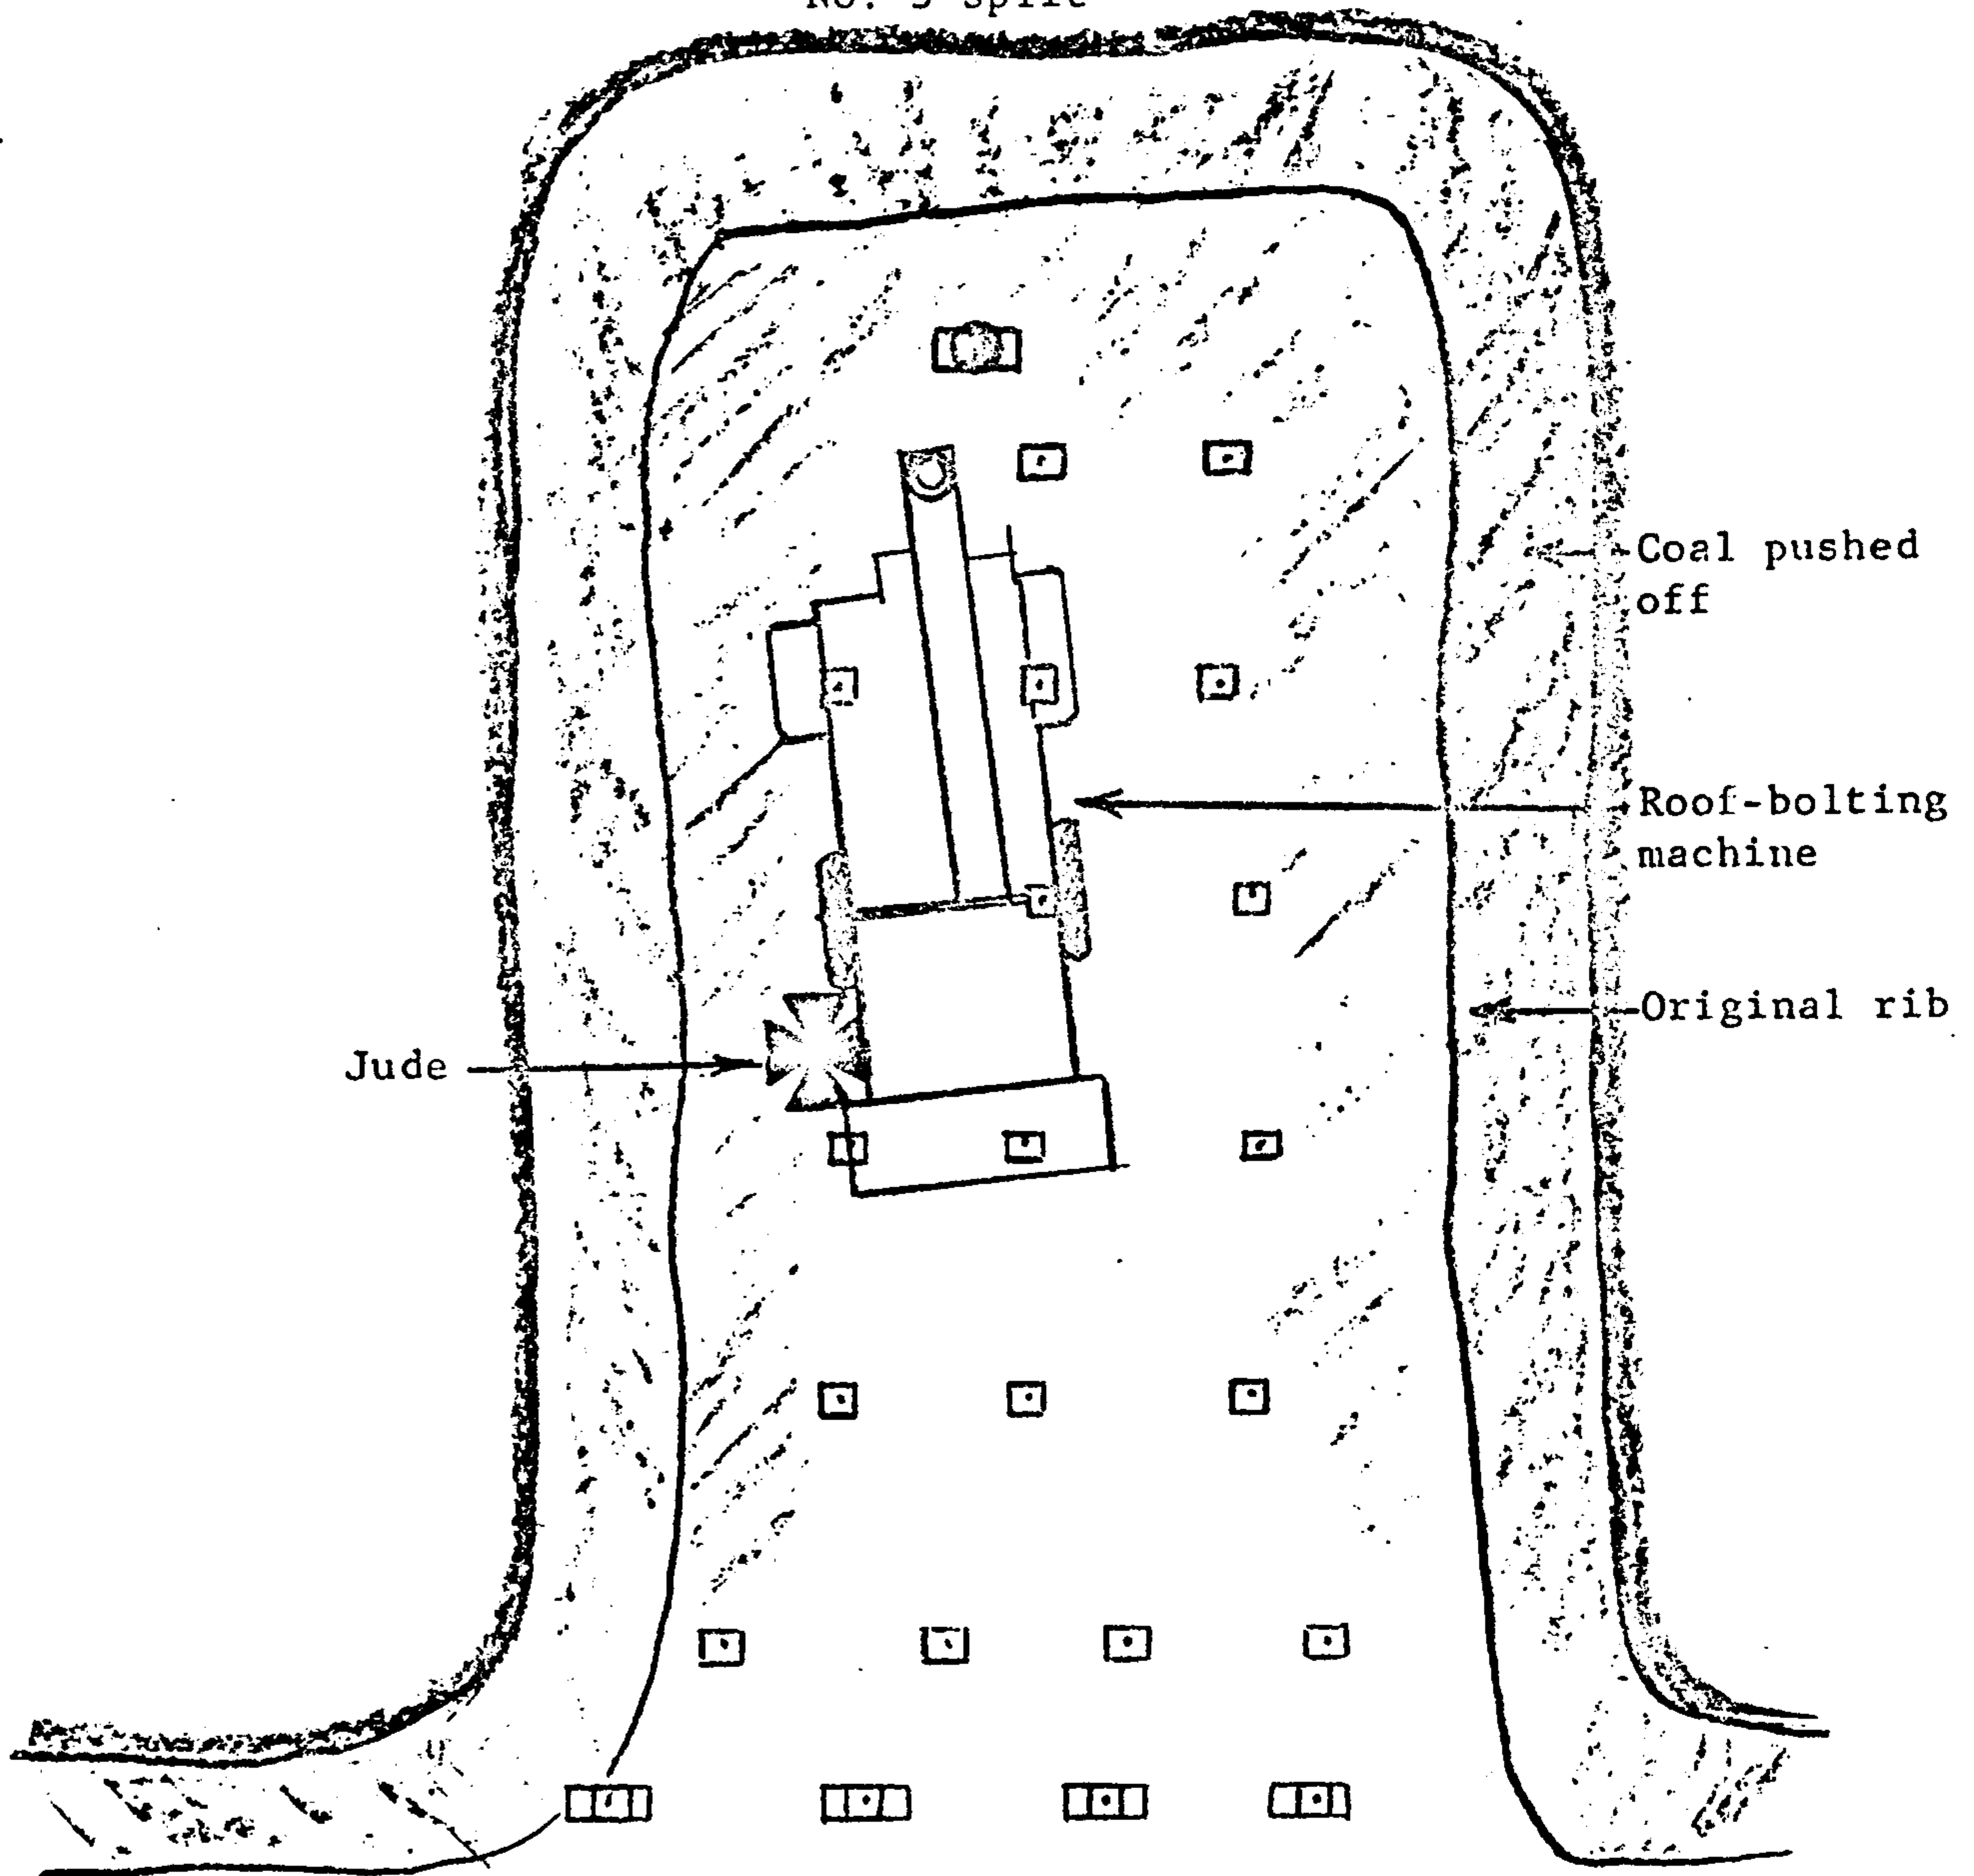
SKETCH NO. 3

Area affected by coal
outburst
